**PETITION OF THE
THIEF RIVER FALLS AIRPORT AUTHORITY
FOR MPCA PERMIT**

Letter of Correction

Memo

DATE: November 8, 2010
SUBJECT: Thief River Falls Airport Runway Review.

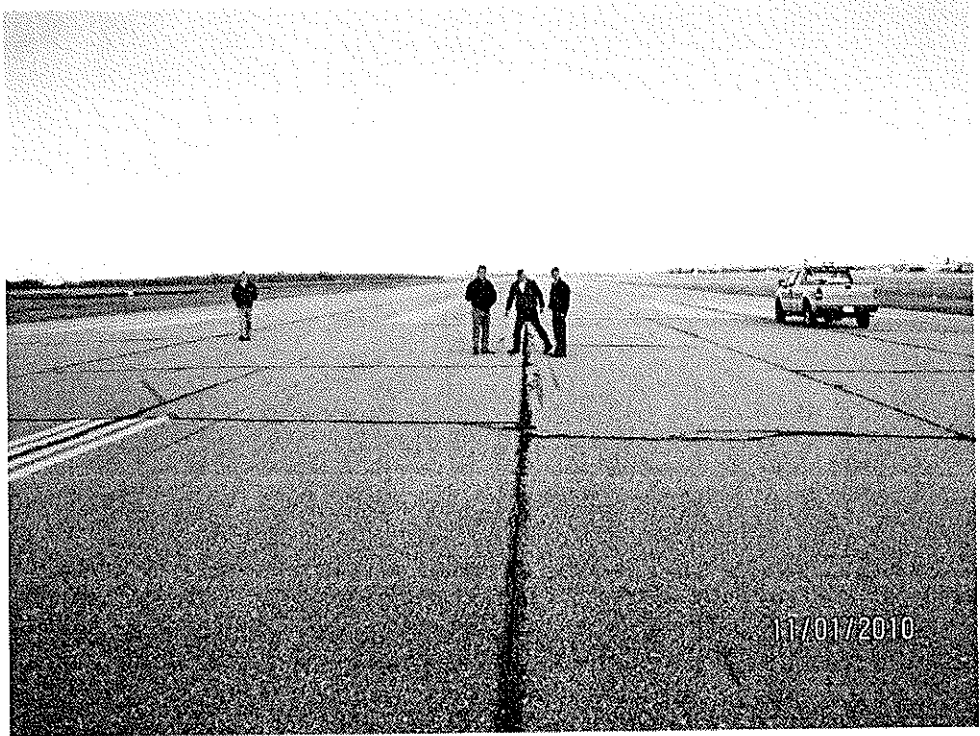
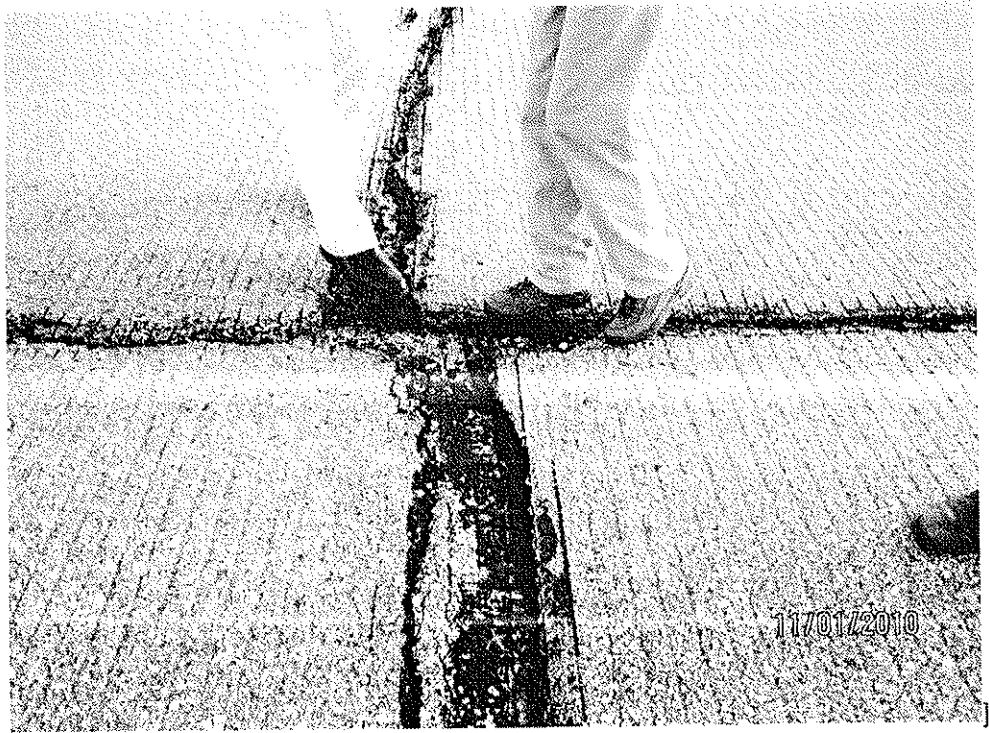
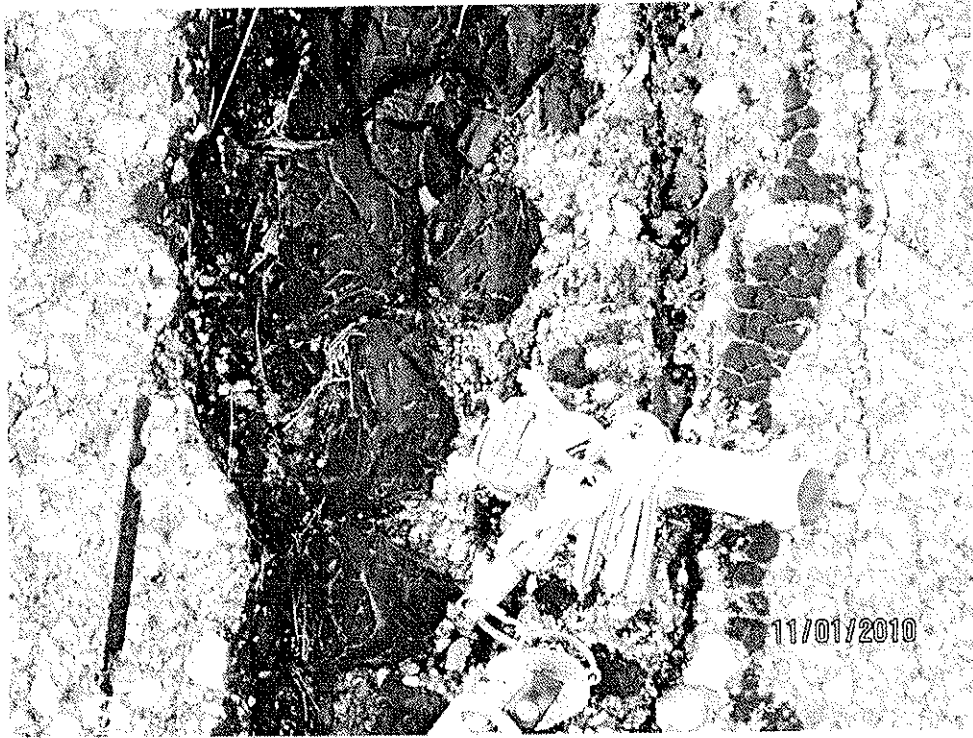
On November 1st I had the opportunity to review the Thief River Falls Airport. The main runway is an asphalt pavement approximately 12 inches thick full depth over variable base materials. The last over lay was placed 16 years ago. The reason for the review was to help determine what the best method to improve the condition of the runway. The main issue the runway is suffering from severe cracking. See pictures below. The asphalt away from the cracks is aged and pocked. It is starting to lose aggregate due to loss of fines. The options available in my opinion are the following:

1. Mill three (3) inches and overlay three (3) inches. I do not think this is the best option because the cracks are cupping, average basin of the depressed pavement close to three (3) feet wide. I stepped on some of the pavement alongside the cracks and I could see the pavement depress under my weight. This tells me that the asphalt at the cracks is stripping and losing strength. If mill and overlay goes forward, to fix runway I would recommend doing some test pits over cracks to determine how bad the asphalt is. My best guess is that within two (2) to five (5) years the cracks would be back and as bad as they are now.

2. The second method would be to mill six (6) inches of asphalt and then do full depth recycling (FDR) stabilized with asphalt emulsion followed with six (6) inch overlay. This option would destroy the current crack pattern and would give many years of performance. If the current traffic stays the same this would be my first choice. I strongly recommend using the proper performance grade (PG) of asphalt binder to slow development of new cracks. The new pavement with regular preventive maintenance (crack sealing) should last 15 to 20 years.

3. The third options is to mill off six (6) inches of the existing asphalt and then do FDR stabilized with asphalt emulsion for the remaining asphalt. Pave the stabilized base with eight (8) inches of concrete pavement. This would give the owners a 50 to 60 year fix that in my opinion could handle any increase in traffic and size of planes using airport.
